EPSON Product Support Bulletin

| PSB #: | PSB.2007.04.001 | Authorization: | <i>[Signature]</i> |
| Subject: | Scanning Application Force Quits on Mac OS 10.4 | | |

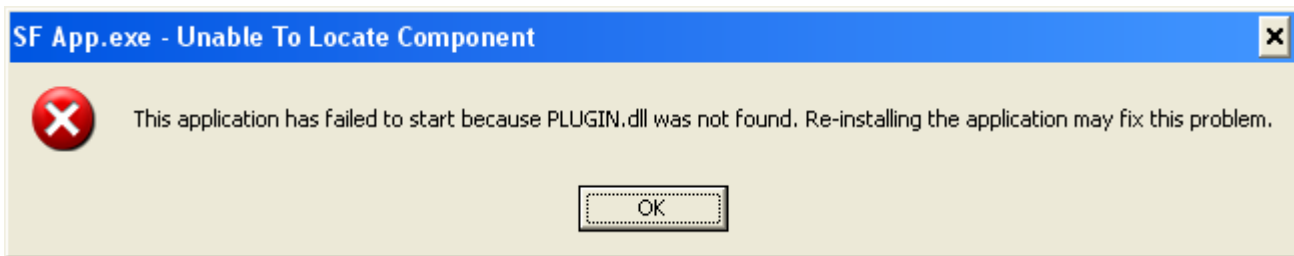
Next, if you click on the "Import" button in Windows XP, you will see the following error message:

This occurs because the "Plugin.dll" file does not get copied to the Windows "System32" folder.

- #1) Manually copy the Photoshop Elements "Plugin.dll" file to the Windows "System32" folder.
 1. If you have installed Photoshop Elements 2.0 in the default location, the Elements "Plugin.dll" file can be found in: "C:\Program Files\Adobe\Photoshop Elements 2." Open "My Computer" and navigate to this folder. If you did not use the default folder, then navigate to the folder you selected or created for Photoshop Elements 2.
 2. Copy the file and then navigate to your Windows "System32" folder. The Windows "System32" folder can be found in the Windows Operating System folder. Typically it will be "C:\Windows\System32" or "C:\WinNT\System32." Then paste a copy of the Plugin.dll file into the "System32" folder. This will prevent the Plugin.dll error from occurring.

#2) The second way to resolve this error is to upgrade the version of SilverFast. Follow the download and installation steps outlined below.

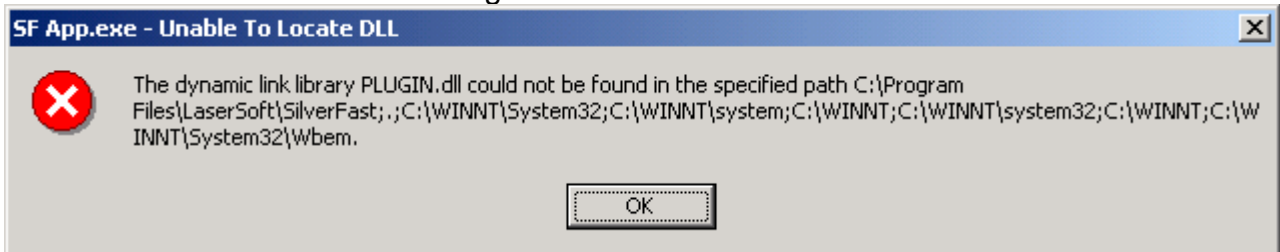
in Windows 2000 the error message looks like this:

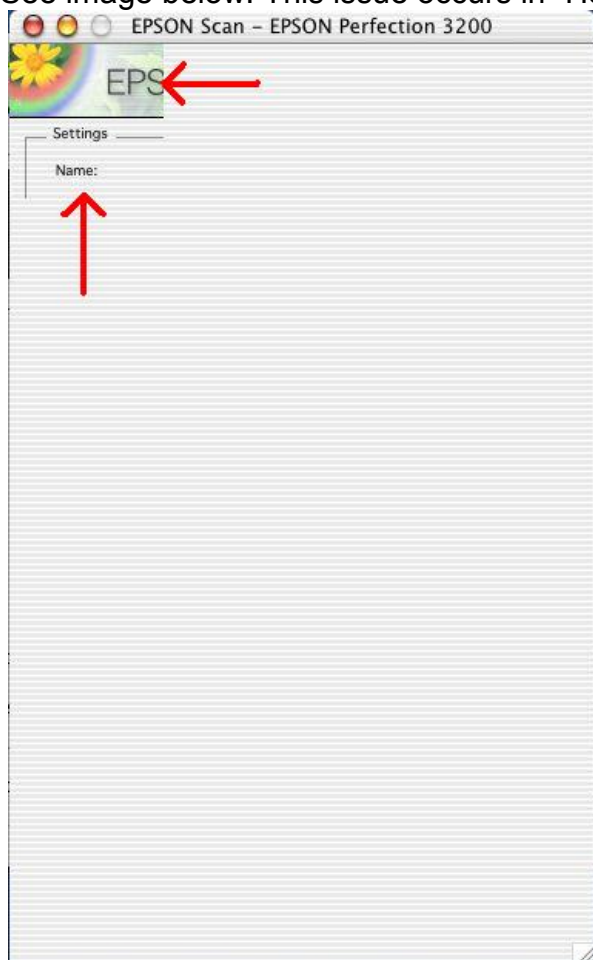
When scanning with Epson Scan Driver v.1.21A in ArcSoft PhotoBase v. 2.5 in OS 10.2.x, the Epson Scan user interface screen does not refresh itself properly after a scan. Instead, the user interface window displays as a blank except for a 1" x 1" square in the upper left-hand corner. See image below. This issue occurs in "Home" and "Professional" modes.

Comments: This problem does **not** occur in the other two ArcSoft Suite applications (Panorama Maker 3.0 and PhotoStudio 4). The issue does **not** affect Adobe Photoshop Elements 2.0, or any

other TWAIN compliant applications. In Epson Scan's Professional Mode, if you grab the "resizer handle" (located in the lower right-hand corner) and resize the user interface window, the window will refresh itself properly.

A patch is now available. Go to ArcSoft's PhotoBase Support page at:

<http://www.arcsoft.com/en/support/downloads/patches.asp?title=8> to download and install the patch file. If this link is not working, visit ArcSoft's website at: <http://www.arcsoft.com/en/index.asp> and navigate to the PhotoBase support Page to find the patch file. If you have questions about your ArcSoft product contact ArcSoft's Technical Support at (510) 440-9901 or fax them at (510) 440-1270.

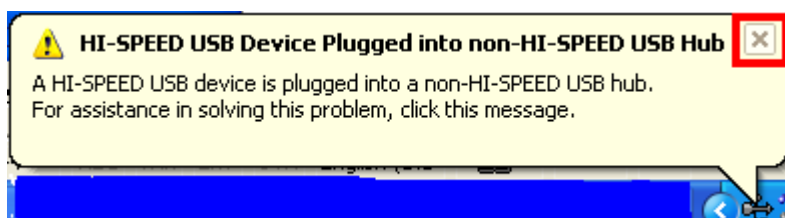
This bulletin was created to inform you of a Windows XP warning message that comes up when an EPSON HI-SPEED USB (USB 2.0) scanner is connected to a non-HI-SPEED USB (USB 1.1) Port. The message is only an indication that Windows XP recognizes a USB 2.0 scanner connected to a USB 1.1 port. This warning message appears the first time the scanner is connected to the computer, and every time the scanner is powered on. It is NOT an error message. The message cannot be disabled, but you can close it by clicking on the "X" as shown in the red box below.
